## Nacogdoches Historic Landmark Preservation Committee

1. Call to order.
2. Approval of minutes
  - A. Approval of minutes: July 14, 2021
3. Regular Agenda
  - A. Discuss and consider Certificate of Appropriateness for property located at 318 E. Main Street.  
COA #2021-006
4. Adjourn.

318 East Main Street | Nacogdoches, Texas | January 2021

## EXISTING CONDITIONS

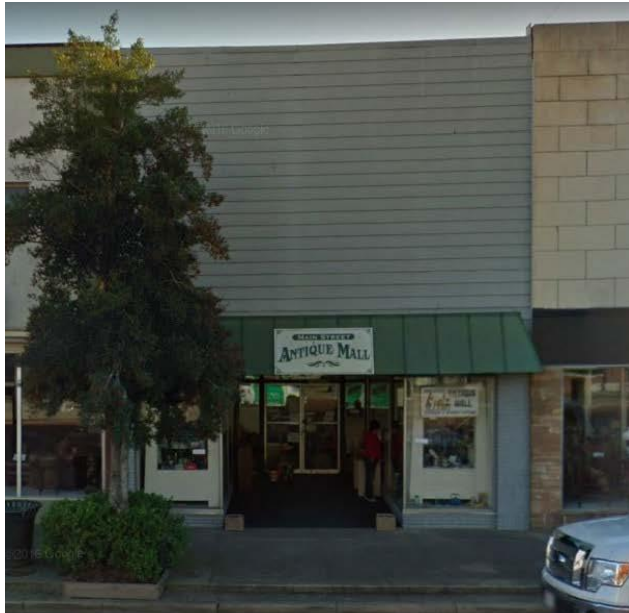
2013 - Slipcover removed shortly after this photo was taken

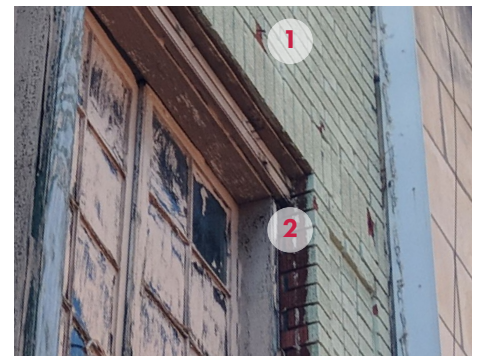
Brick Detailing at Upper Facade

(3) As shown in the photo, a distinct brick bonding pattern is present along the upper facade. This unique brick detailing is important in defining the overall historic character of the building and should not be altered or obscured. Additional on site investigation should also be conducted in order to verify the extent of the damage caused by the removal of the slipcover to the brick's surface. When the horizontal siding or slipcover was directly applied to the upper facade, the framework that was built and anchored into the building appears to have severely damaged small portions of the brick's face. (1) Remnants of some of the nails can be seen in the first photograph. (4) In addition to the above, further investigation is also required in the area surrounding the canopy. Consider carefully removing the siding that remains in place. Further guidance on the removal of the existing mansard canopy is provided on the following page. Additional information on how to clean historic masonry building and chemically removing paint can be found in the [National Park Service Preservation Brief #1](#) and [#6: Dangers of Abrasive Cleaning](#) as well as the U.S. General Services Administration technical document for [Chemically Removing Paint and Repaint Brick Masonry](#).

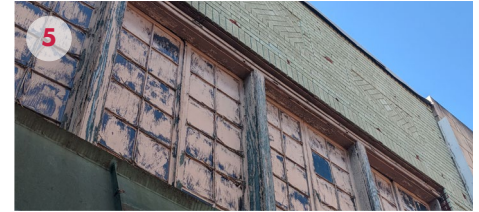
**Casement Windows (Upper Floor):** As shown in the photograph, (5) the casement windows remain intact and may require significant repairs. Further investigation should be conducted in order to determine the windows' material and condition. This is important to know prior to executing any conservation techniques. The windows are important to the overall character of the property, and attempts to repair the windows needs to be undertaken first before replacement is considered. Replacements for missing or severely damaged windows should be reconstructed in kind.

*The casement windows remain intact and may require significant repairs. Further investigation should be conducted in order to determine the windows' material and condition. Replacements for missing or severely damaged windows should be reconstructed in kind.*

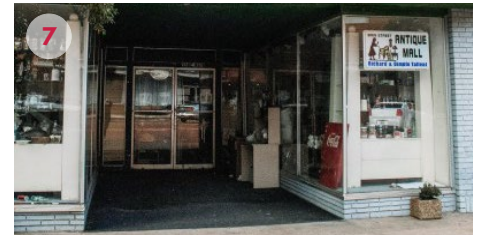
**Storefront: (7)** While the existing storefront may not be the original design nor the desired aesthetic, the changes that were made to the building were completed over 50 years ago, which makes them historic in their own right. This is supported by the Secretary of the Interior Standards for Rehabilitation and the Nacogdoches Design Guidelines. For additional guidance on the Certificate of Appropriateness requirements, refer to the City of Nacogdoches' Code of Ordinances, *Division 5 Certificate of Appropriateness, Section 50-157. - Criteria for approval: (e) Previous alterations*. Both Standards #3 & #4, specifically support the preservation and repair of the existing storefront. Per [Standard 3](#): Each property shall be recognized as a physical record of its time, place, and use. Changes that create a false sense of historical development, such as adding conjectural features or architectural elements from other buildings, shall not be undertaken. [Standard 4](#): Changes to a property that have acquired historic significance in their own right will be retained and preserved. In this case, replicating the architectural elements from 422 East Main Street will create a false sense of historical development that was never present on 318 East Main Street. Replicating the features from a different property also destroys and/or diminishes the historic character that is currently present at 318 East Main Street. The proposed alterations provided in the sketch should not be undertaken. (8) The distinctive materials present in this property, such as the aluminum and Norman brick, including the recessed configuration, and construction techniques, characterize this property and have become a part of the historical evolution. Before any conservation technique is considered, it is important to first evaluate the overall conditions of the aluminum storefront in order to determine whether more than protection and maintenance is required. Based on the photographs, it appears to be in relatively good

condition with a couple of glass panes that will require replacement. Further investigation should also be conducted in order to determine and confirm the type of metal and condition. This is important to know prior to restoring because each metal type has its own properties and may require a different treatment. If it is determined that the storefront is severely deteriorated and beyond repair, then the owner may consider an appropriate replacement. However, simply because a single component of a storefront needs repair, this should not be a justification for replacing an entire storefront. In the case that the majority is beyond repair and metal components have deteriorated to a point where they have actually failed or are completely missing, replacement is the only reasonable course of action. If it is determined that this is the case, the new design should be compatible with the size, scale, color, material, and character of the building. The new design should also maintain the historic planar relationship of the storefront to the facade of the building. If using the same material is not technically or economically feasible, then a compatible substitute material may be considered. Refer to the [National Park Service: Preservation Brief #11: Rehabilitating Historic Storefronts](#) for guidance. During this process, it is recommended to follow-up with Texas Main Street staff for further assistance.

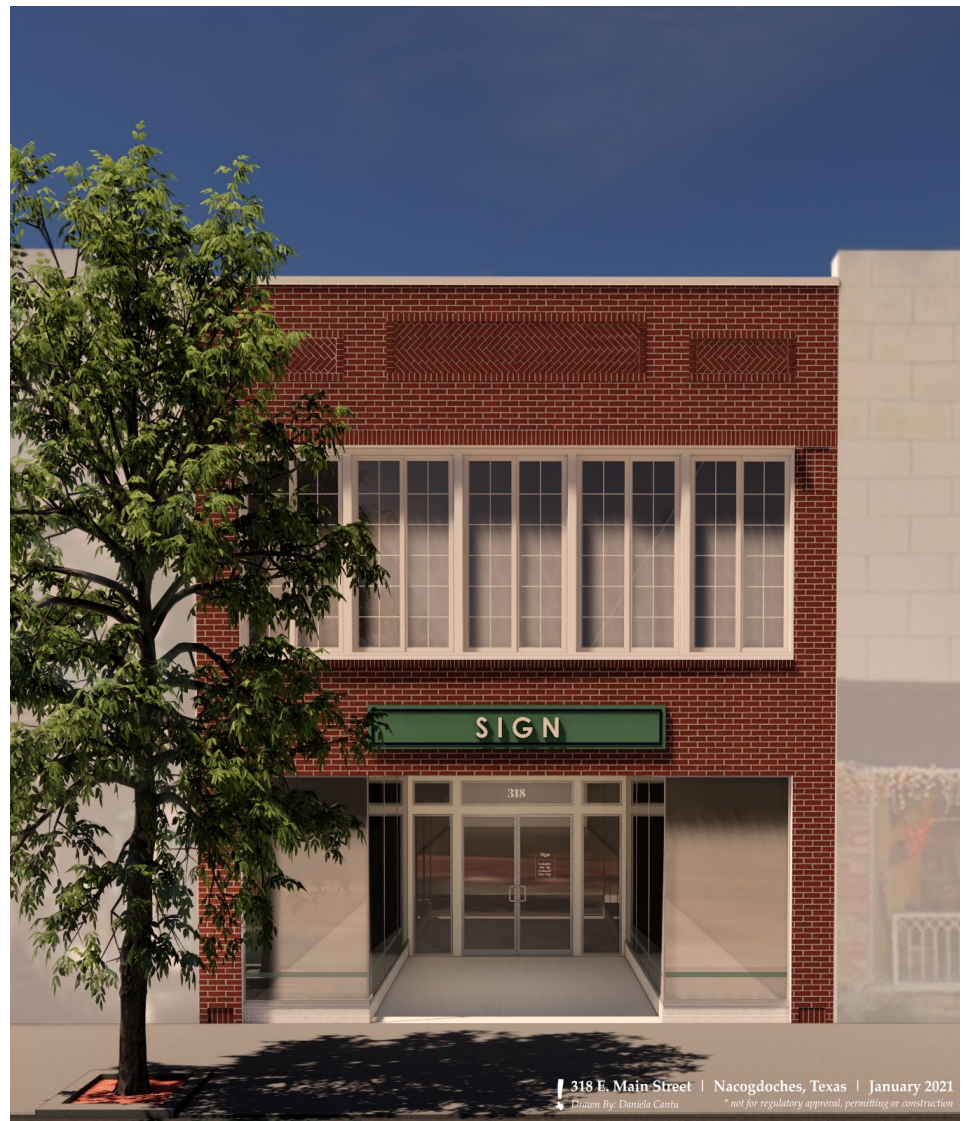
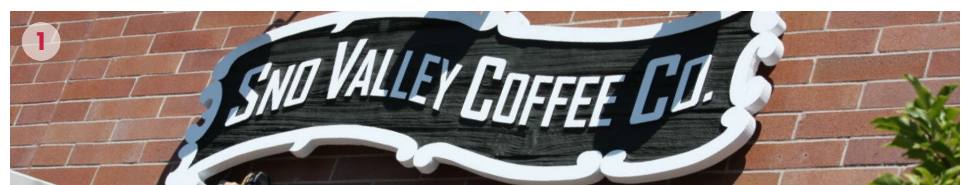
**Canopy Removal:** In the rendering, it was assumed that the brick continues directly below the canopy and remains in good condition. It was also assumed that transom windows do not remain in place. However, the condition is unknown. Further investigation is required.

**Signage:** The primary panel sign is shown in a sans-serif font, centered and carefully attached. If a sign is attached to the facade, fittings should penetrate the mortar joints rather than brick in order to prevent irreparable damage to the masonry. If the sign is removed in the future, the mortar can then be repointed. The proportions of the sign align with the width of the existing opening. A three dimensional appearance is also created by layering materials, **(1)** similar to the first example provided on the lower right. If an illuminated sign is preferred, then fabrication adjustments for lighting to be incorporated should be considered. **(2)** For the entry doors, vinyl signage at a smaller scale can indicate store hours and the building's address. **(3)** Additional vinyl signage may also be applied to the lower area of the display windows, similar to the example provided.

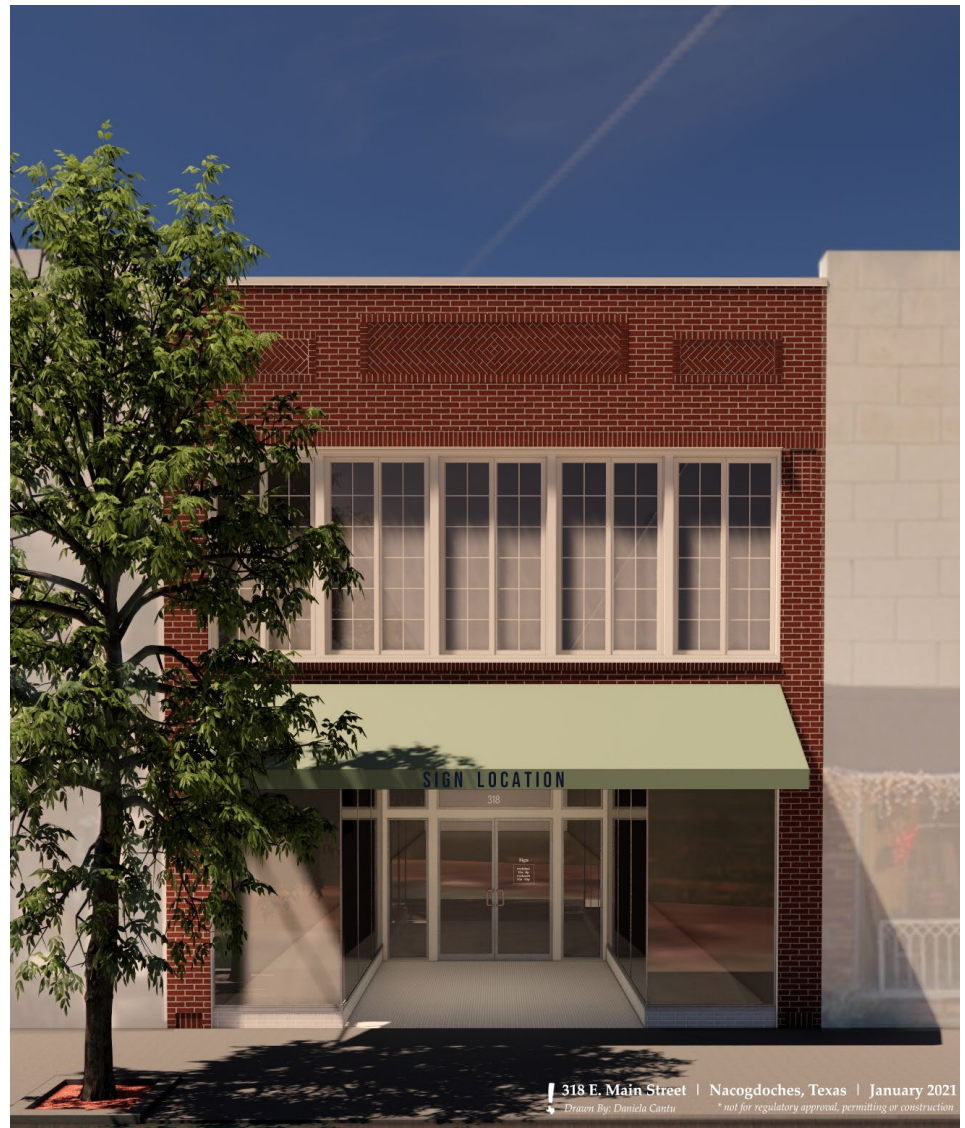
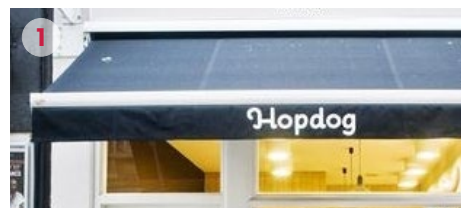
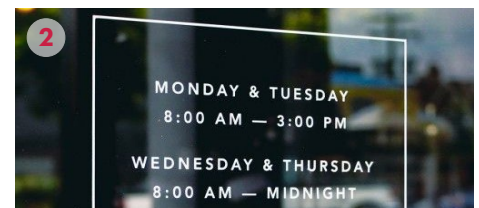
**Fabric Awning + Signage:** In the rendering, it was assumed that transom windows do not remain intact, and portions of the brick are in repairable condition after the removal of the canopy. However, the condition is unknown. Further investigation is required. **(1)** The primary signage can be incorporated into the awnings design, similar to the first example shown on the lower right. **(2)** For the entry, vinyl signage at a smaller scale can indicate store hours and the building's address.

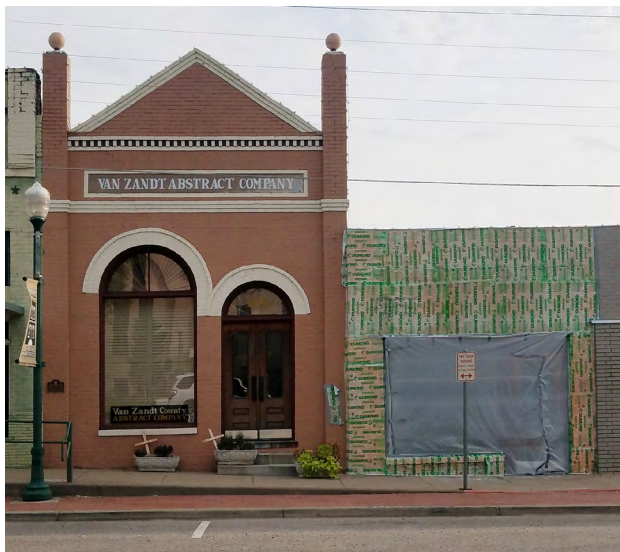
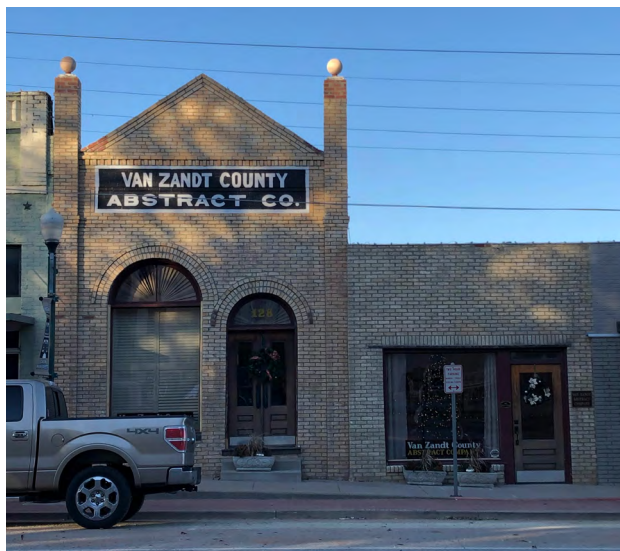
**Above:** Van Zandt Abstract Company in Canton, Texas carefully removed layers of paint from their front facade using Dumond Peel Away Poultice system.

**Below:** This process revealed the natural color of the brick and a ghost sign.

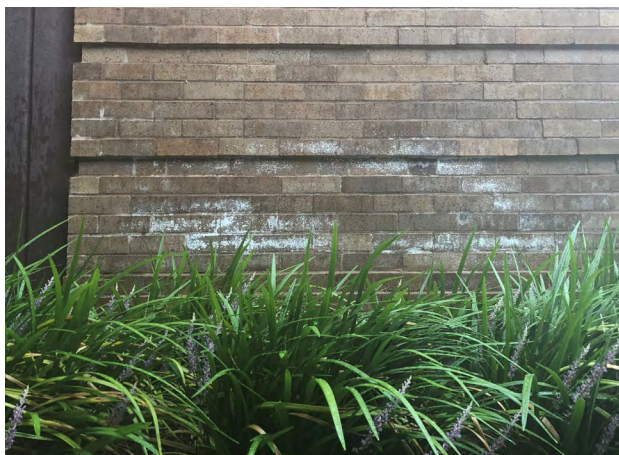
**Efflorescence:** excessive moisture within the masonry wall causes salt to seep to the surface, leaving white deposits known as efflorescence.

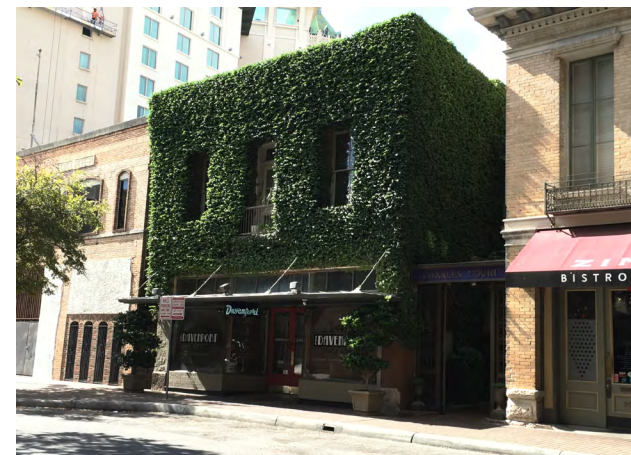
**Vines and Vegetation:** Plant life growing on exterior walls causes a range of problems, including mortar deterioration and blocking of gutters and downspouts.

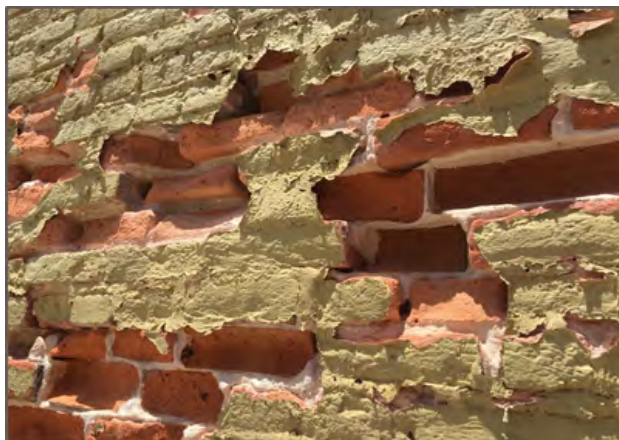
**Painting:** Brick walls are unable to breathe when painted, causing moisture to be trapped and leading to damage. Individual bricks begin to deteriorate and cause structural instability.

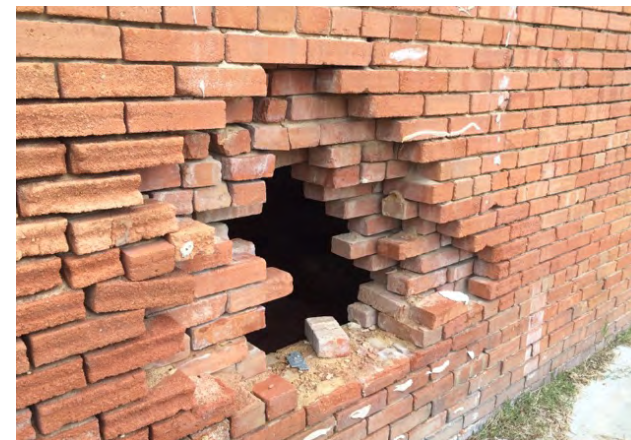
**Missing Mortar:** Mortar should be repointed every 10 years. If mortar is not repointed, loose bricks begin to fall out of the wall construction.

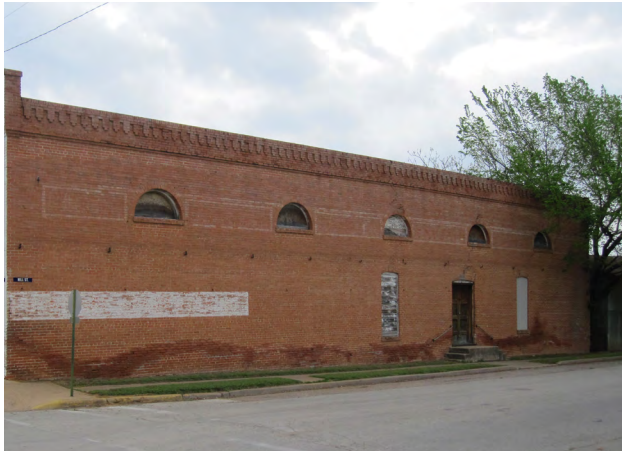
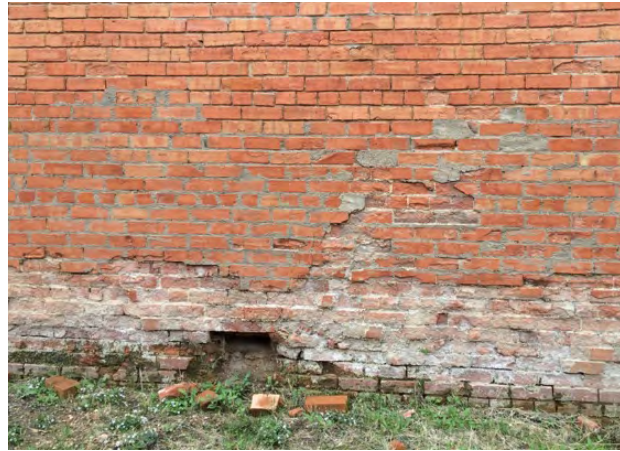
**Rising Damp:** Excessive moisture in the ground, crawl space, or basement is visible on wall surfaces, as the brick appears visibly darker when damp (above left). Moisture causes brick deterioration (above right). Additional drainage around the building or drying of interior spaces is needed.

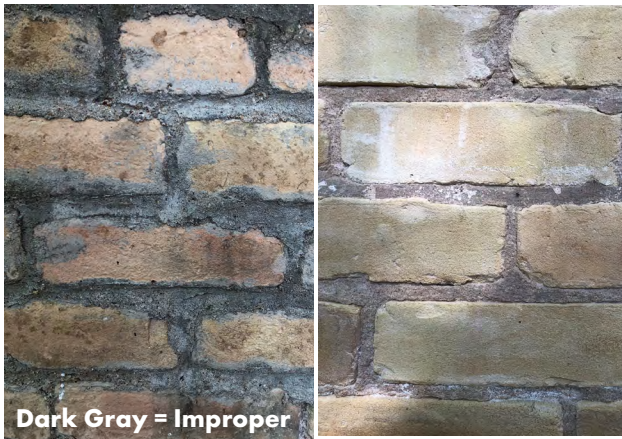
**Improper Mortar Mixture:** Mortar ingredients should be carefully proportioned to match the original mix. Too much Portland cement in the mix causes the mortar to be too strong, and leads to structural cracks.

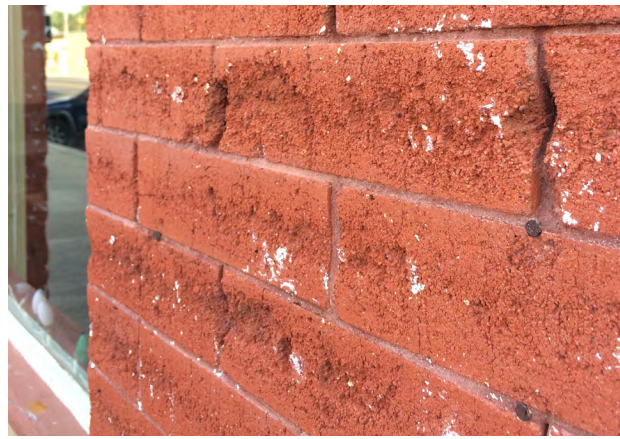
**Abrasive Cleaning:** The exterior brick surfaces have been destroyed due to sandblasting or harsh chemicals, leaving the softer, brick interior exposed.

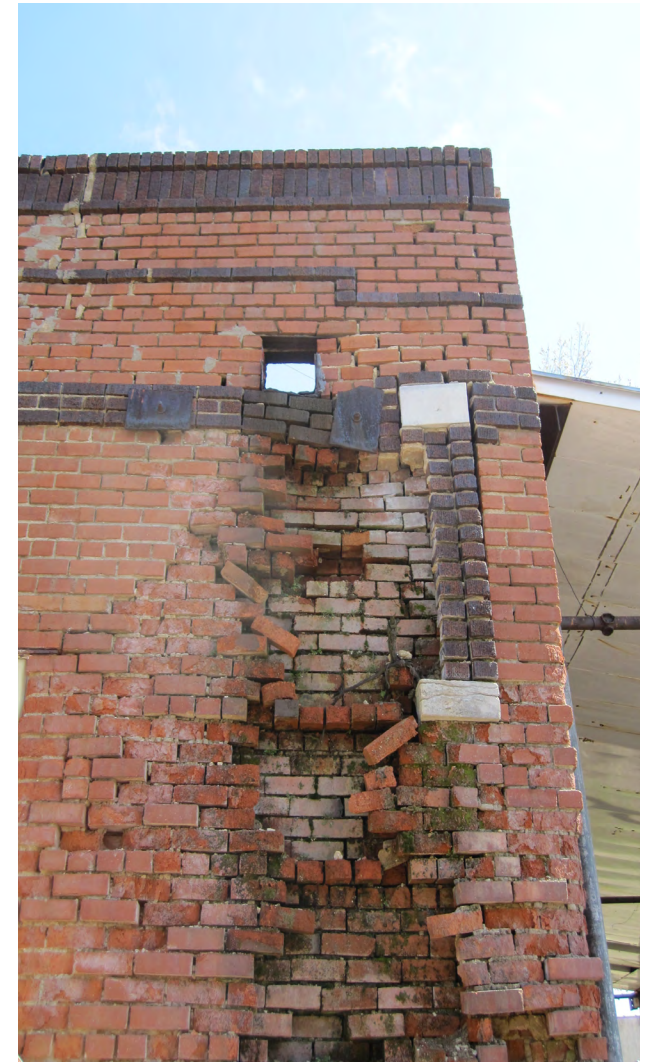
**Missing Downspouts, Gutters, or Roof Flashing:** Excessive water running down the face of brick walls quickly causes eroded joints and structural failure.

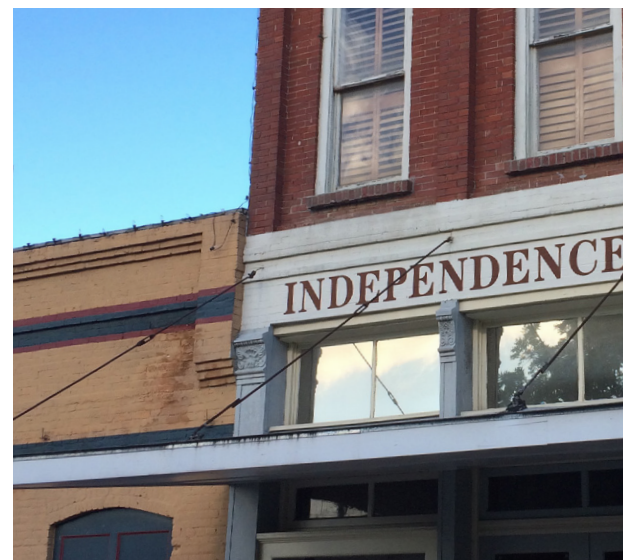
*Above: In the diagram, tie rods puncture the roof surface. In the image below, the tie rods are attached to the front edge of the canopy. Either attachment style can be used on a new canopy. The tie rods attach to the building with an anchor bolt that passes through the entire thickness of the masonry wall. Anchor bolts should be placed at the mortar joint so that the hole it creates does not damage the brick.*

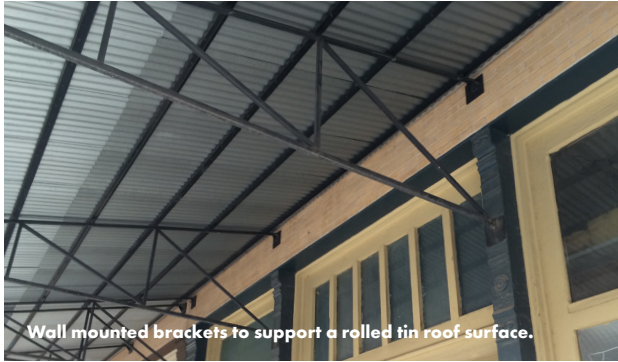
Wall mounted brackets to support a rolled tin roof surface.

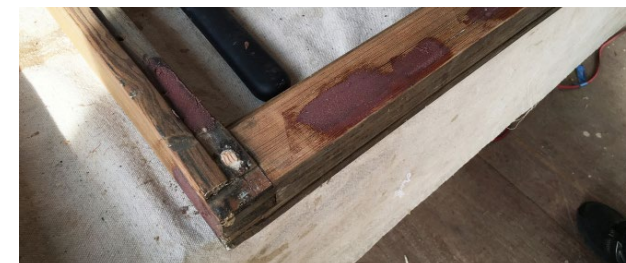
*Below: Red River Restorations uses wood epoxy and small wood dowels to fill holes and deteriorated portions of a historic wood window sash.*
